Land Disposal of San Luis Drain Sediments,  
Panoche Water District, South Dos Palos, California

Joint Project Report by Lawrence Berkeley National Laboratory and  
LFR Levine-Fricke

May 28, 2002

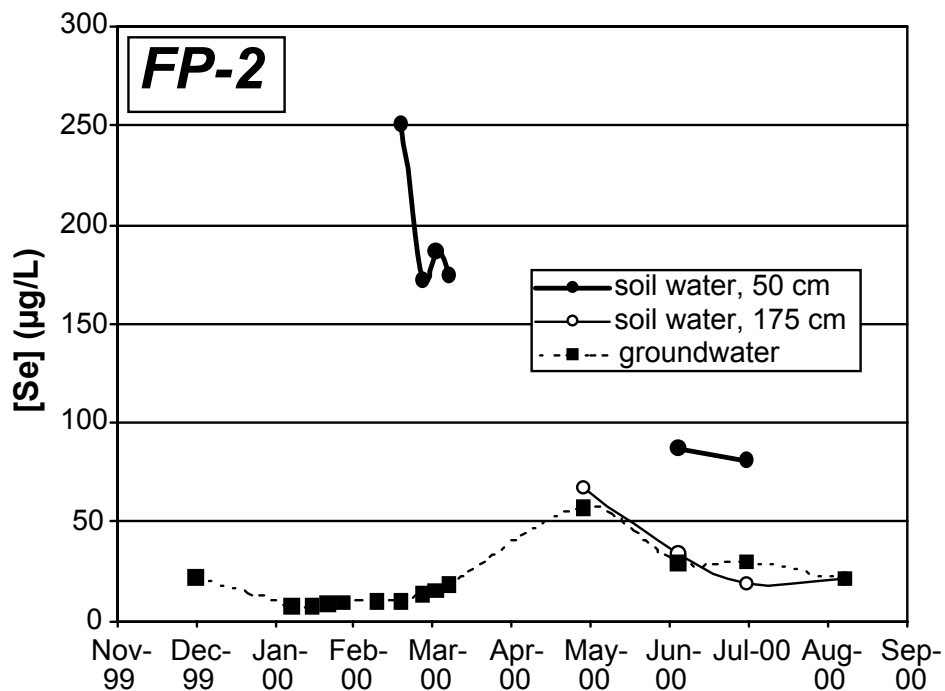
Figure 35: Soil water and groundwater Se in FP-2.

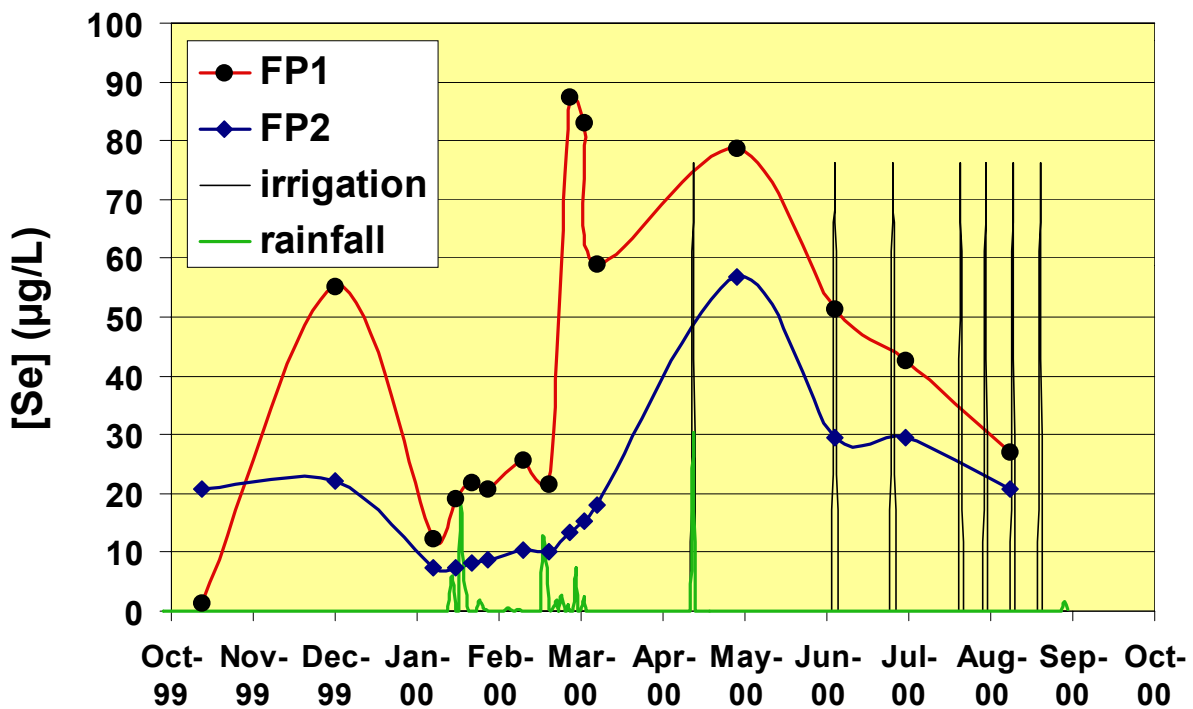
Figure 36: Groundwater Se and irrigation and rainfall events (mm) at farm plot.

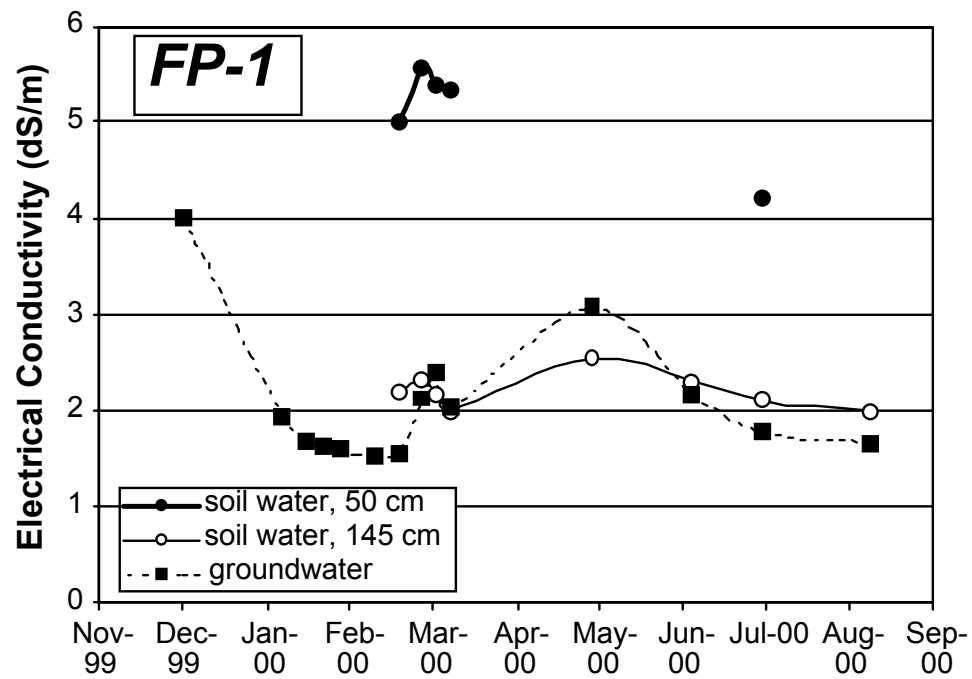
Figure 37: Soil water and groundwater electrical conductivity in FP-1.

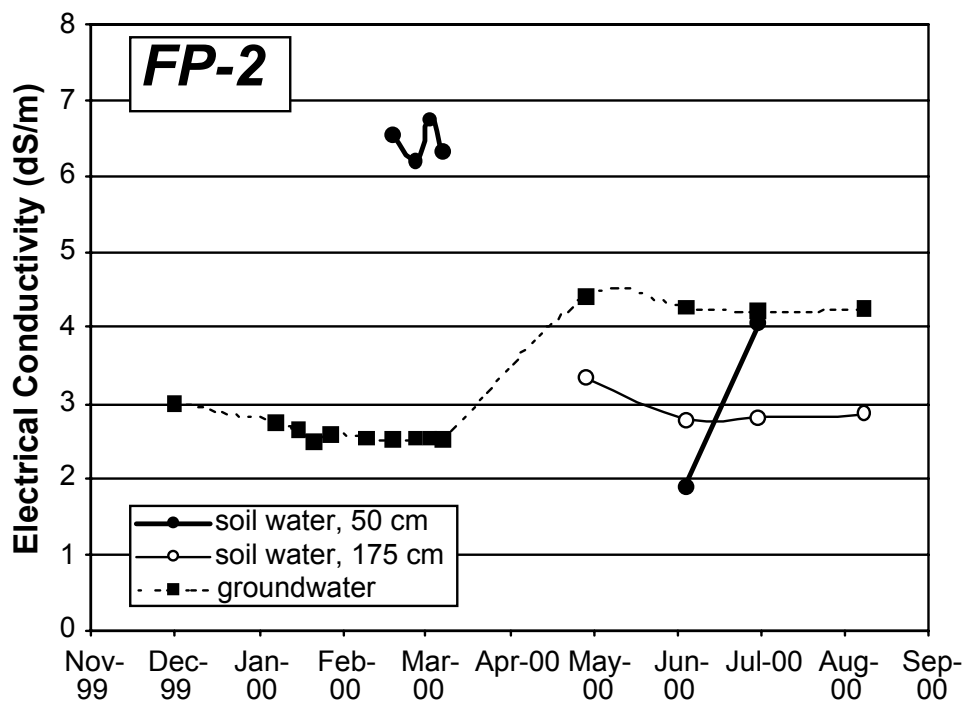
Figure 38: Soil water and groundwater electrical conductivity in FP-2.

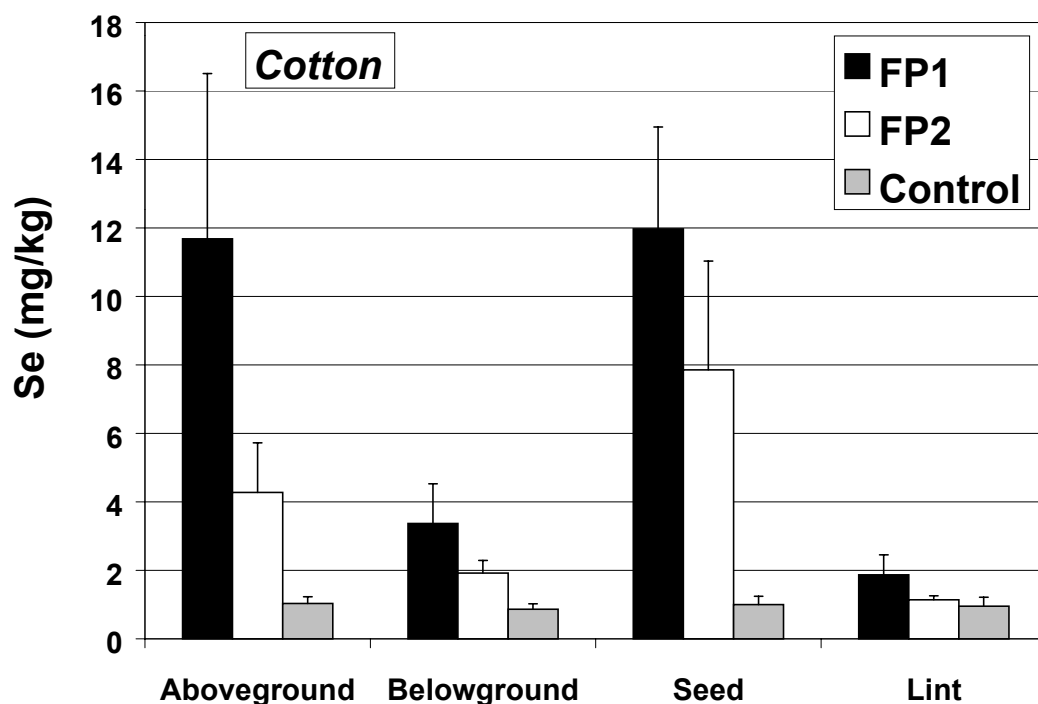
Figure 40: Average Se concentration ( $\pm 1$  s.d.) in aboveground parts (stems and leaves), belowground parts (roots), seeds, and lint of cotton plants from FP-1, FP-2, and a control area, 11/4/00.

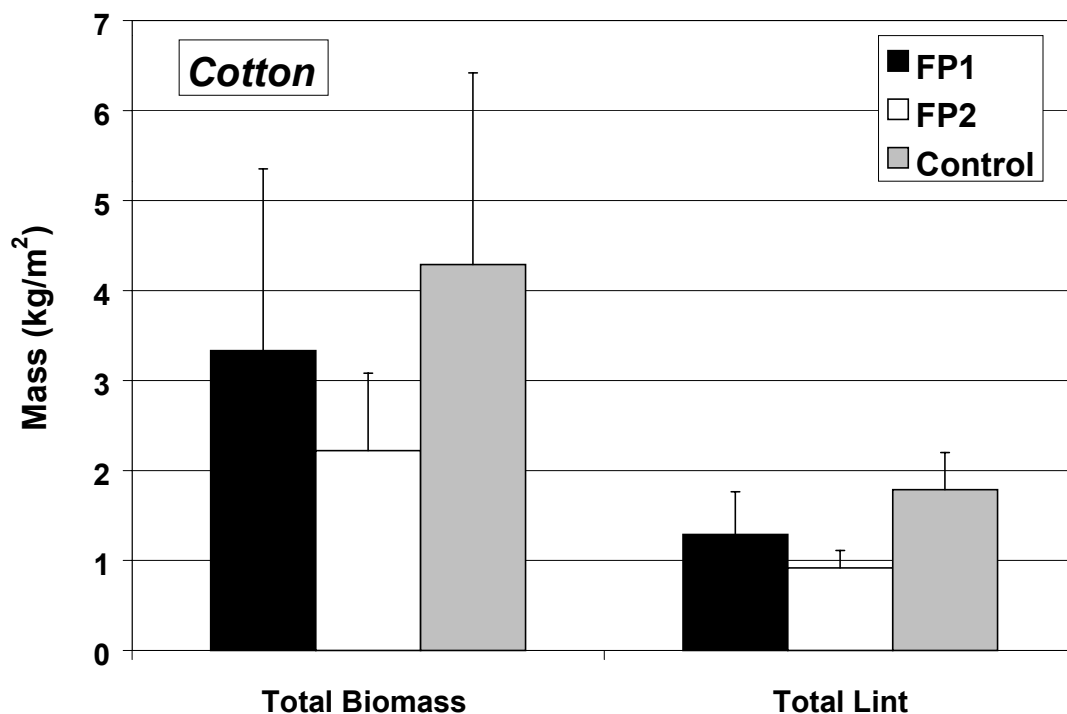
Figure 41: Average cotton biomass and cotton lint yield ( $\pm 1$  s.d.) in FP-1, FP-2, and a control area, 11/4/00.

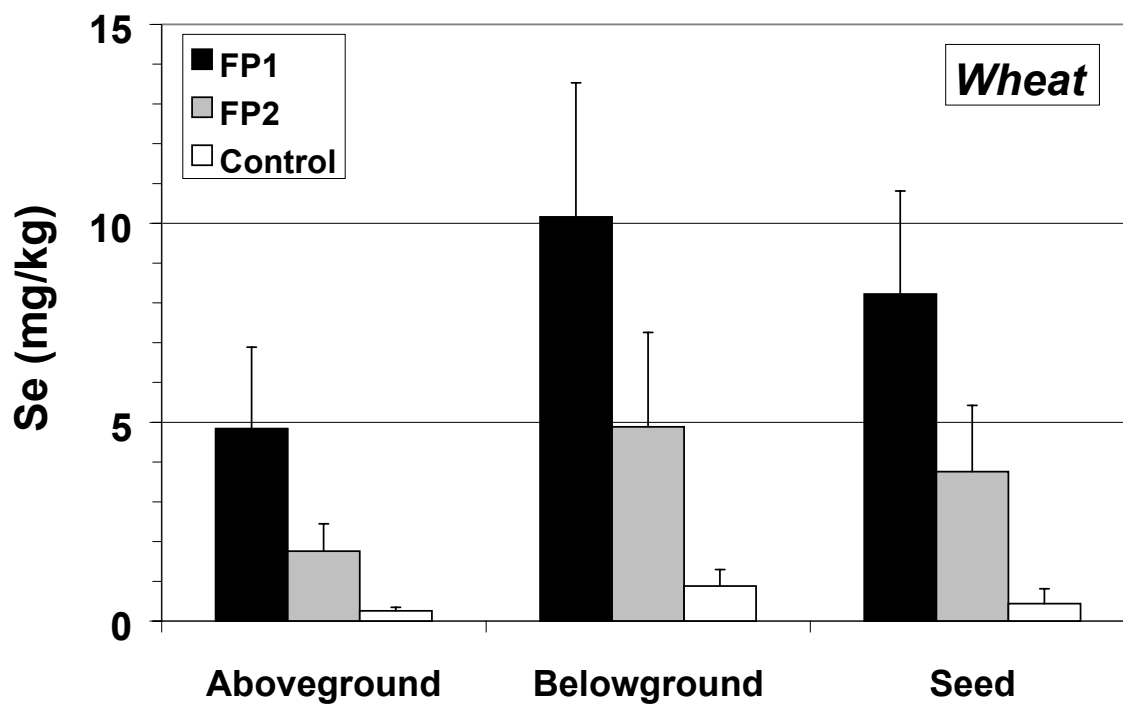
Figure 42: Se concentrations in wheat tissue in FP-1, FP-2, and a control area, 6/7/01.

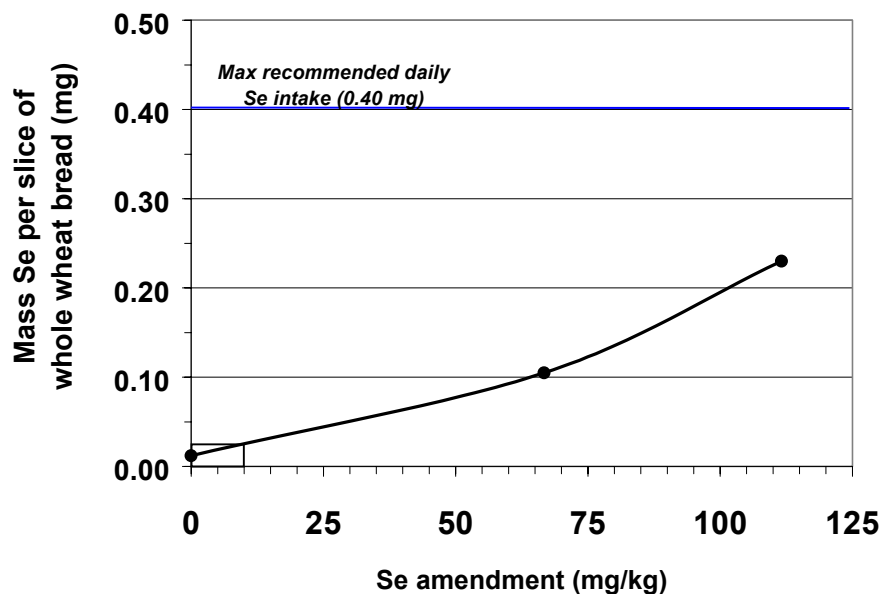
Figure 46: Mass of Se in hypothetical slice of whole wheat bread made from wheat seeds from FP-1, FP-2, and FP-C, compared with the maximum recommended daily Se intake. The box on the lower left indicates the Se concentration range of the majority of SLD sediments.

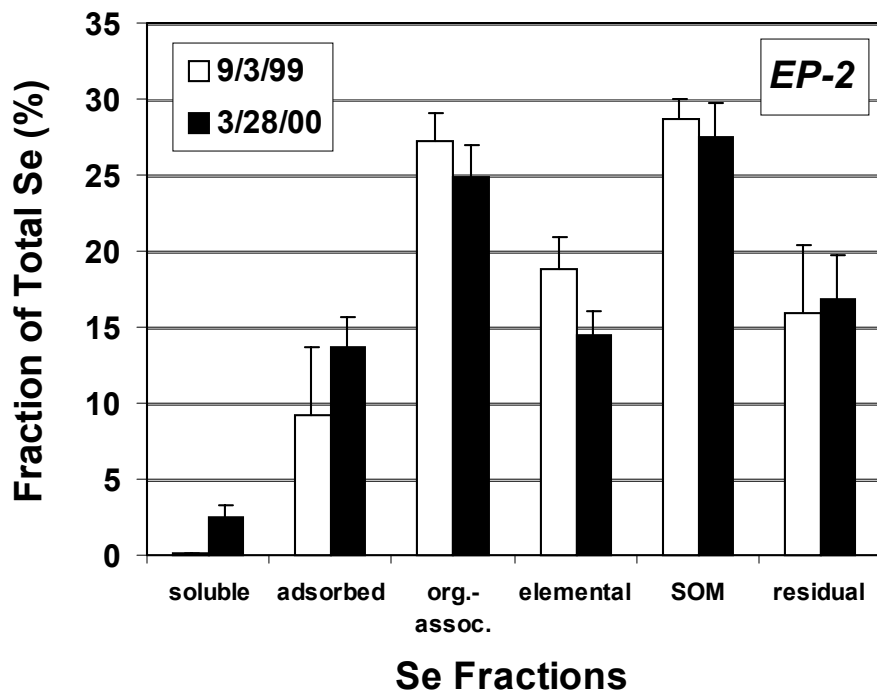
Figure 47: Se fractions in SLD sediment applied to EP-2.

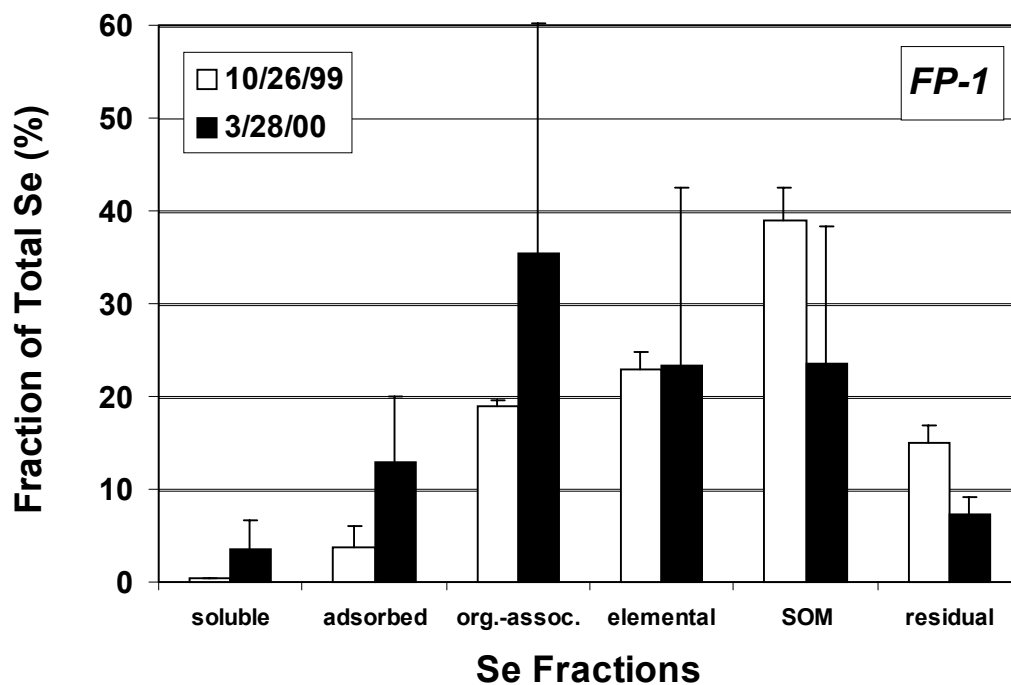
Figure 49: Se fractions in SLD sediment applied to FP-1.

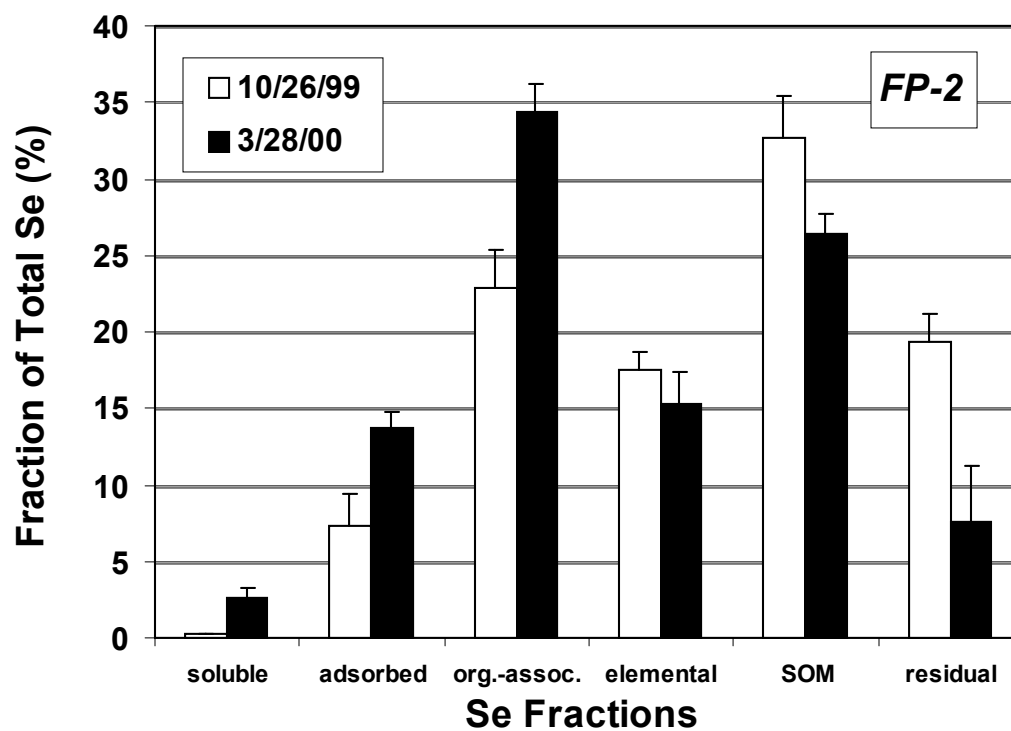
Figure 50: Se fractions in SLD sediment applied to FP-2.

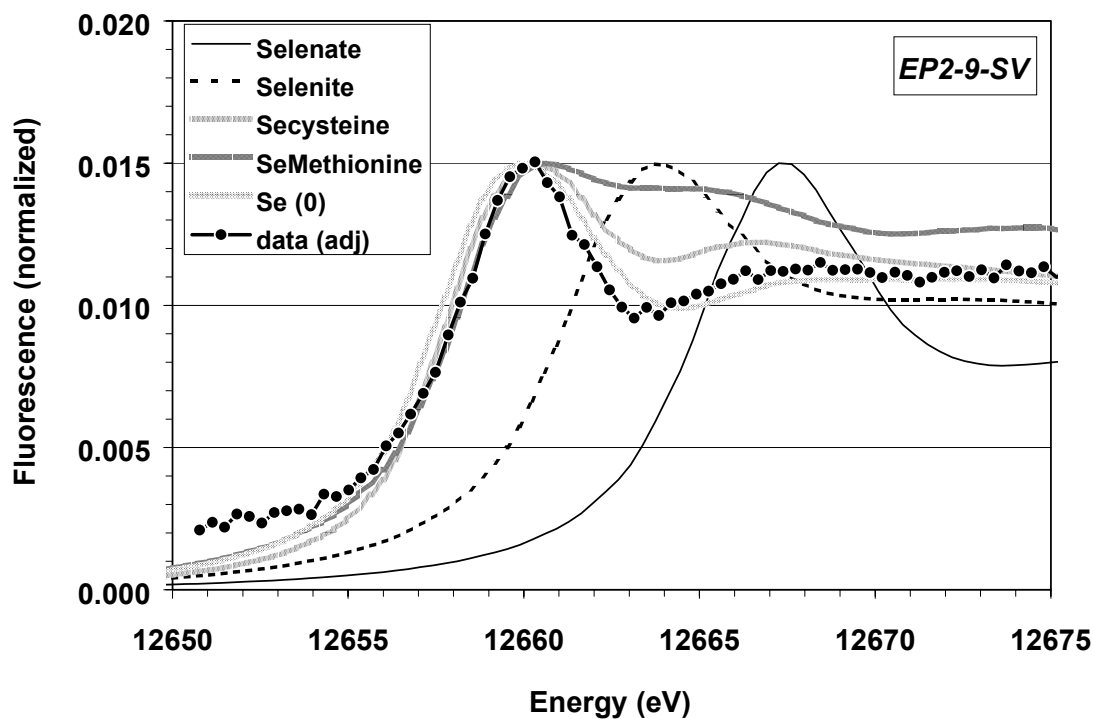
Figure 52: Se K-edge absorption spectra of Se standards and SLD sediment sample EP2-9-SV. Collected on 9/3/99, immediately after application.

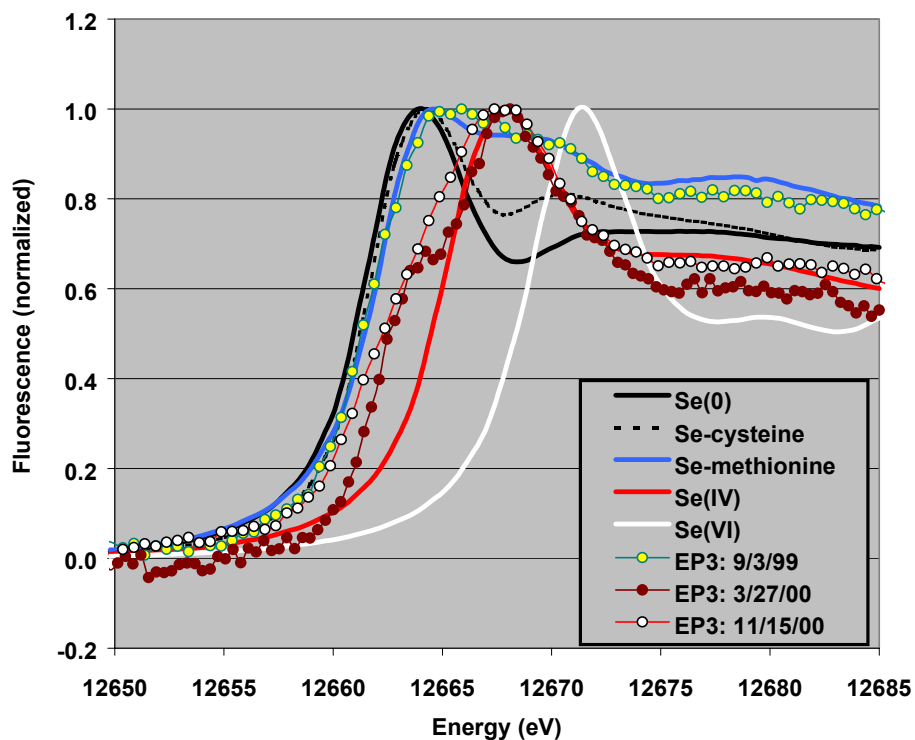
Figure 54: Se K-edge absorption spectra of Se standards and SLD sediment samples. Collected on 9/3/99, 3/27/00, and 11/15/00 from EP-3.

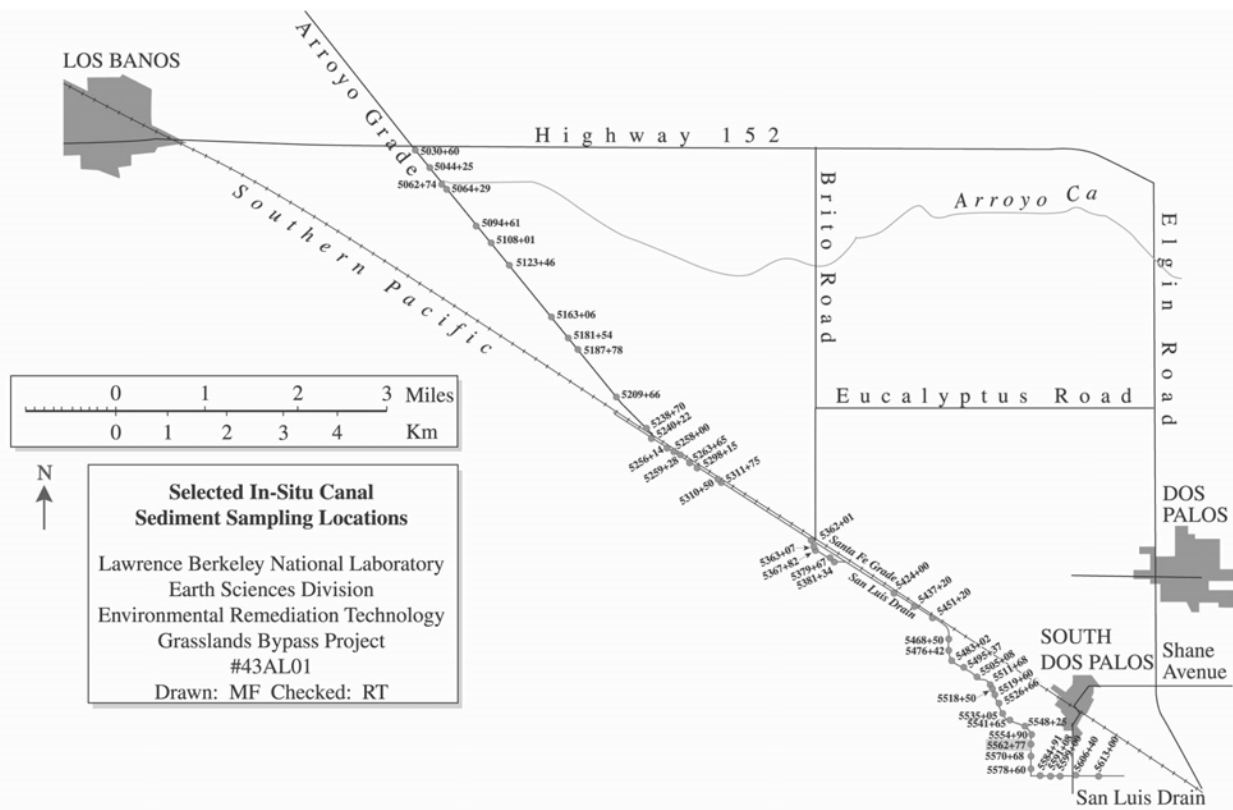
Figure A-1. Location of LBNL sediment sampling points along the San Luis Drain.

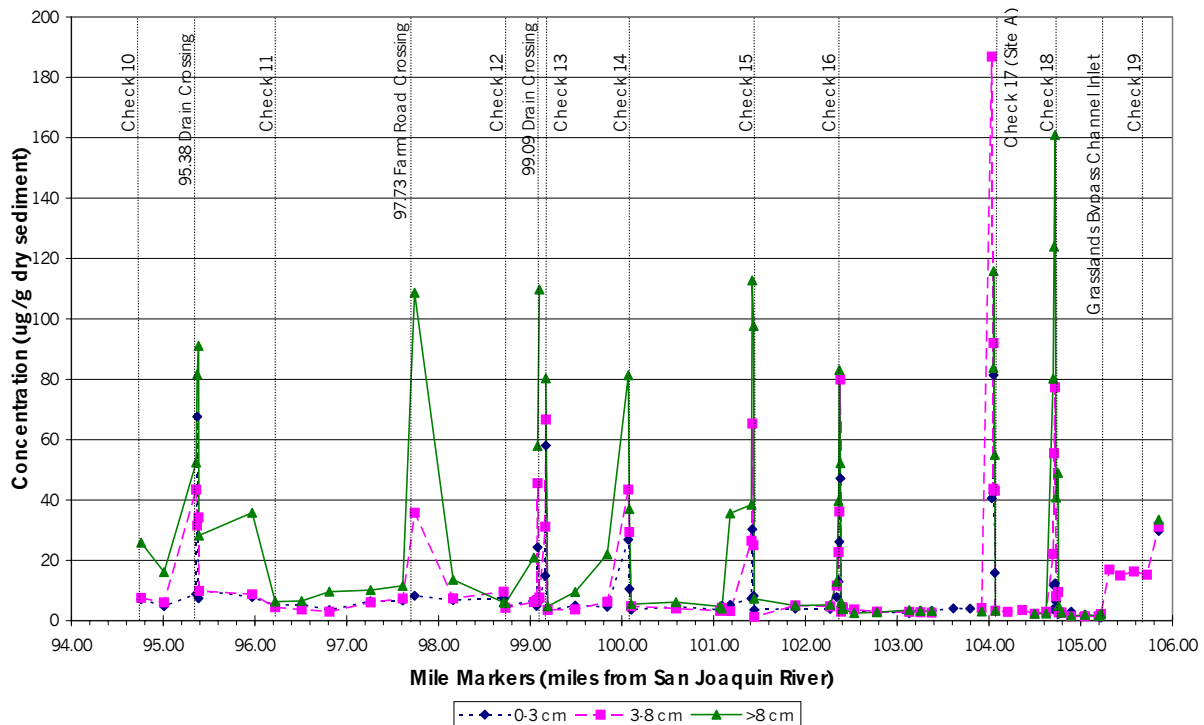
**Chart 2: Histogram showing depth distribution of  
Total Se in San Luis Drain Sediment**  
LBNL Survey, December 1998 - March 1999

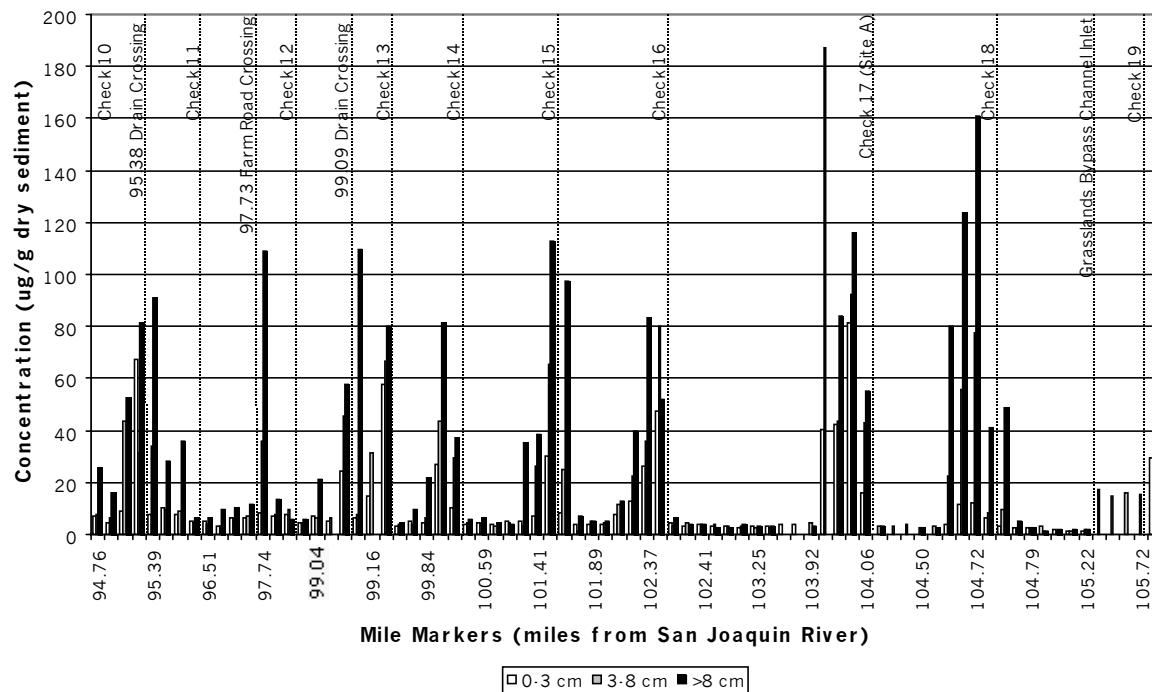
**Chart 3: Distribution of the Mass of Se  
along the San Luis Drain**  
LBNL Survey, December 1998 - March 1999

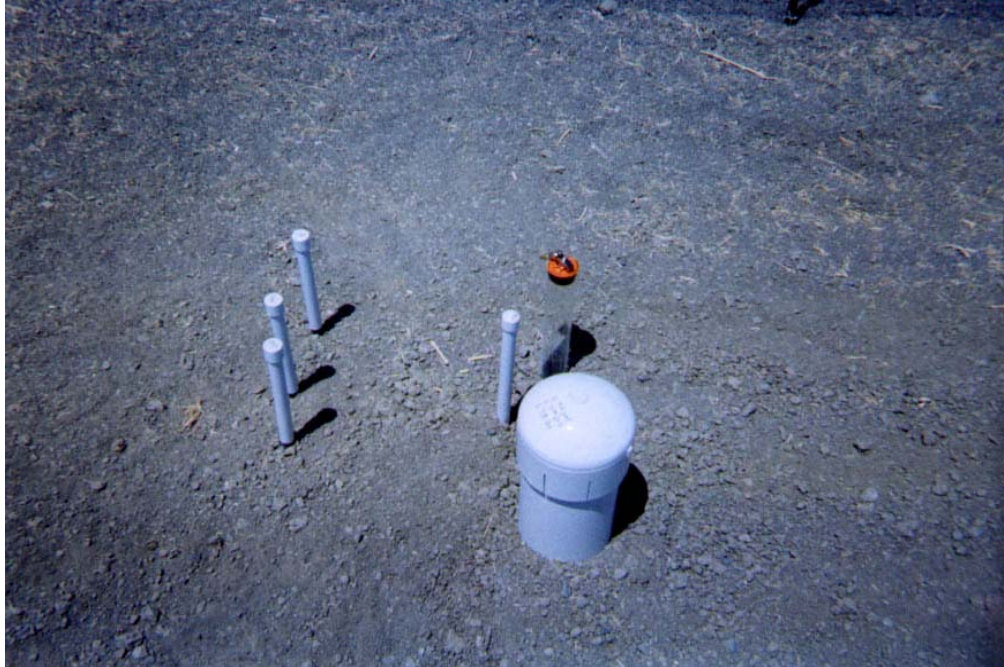
*Figure C.3: Instrument cluster 7 in EP-2. From left to right: tensiometers (covered with PVC pipe), neutron probe access pipe (clear acrylic), and soil water suction lysimeters (under large PVC cap).*

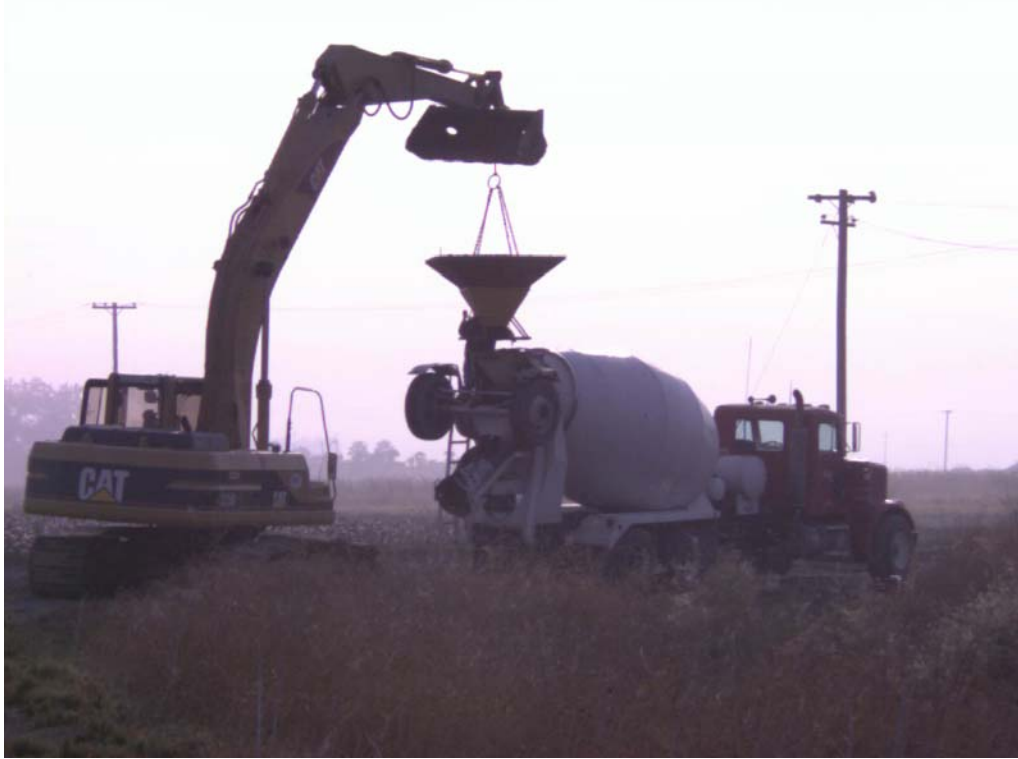
*Figure C.5: SLD sediment being placed in cement truck via hopper.*

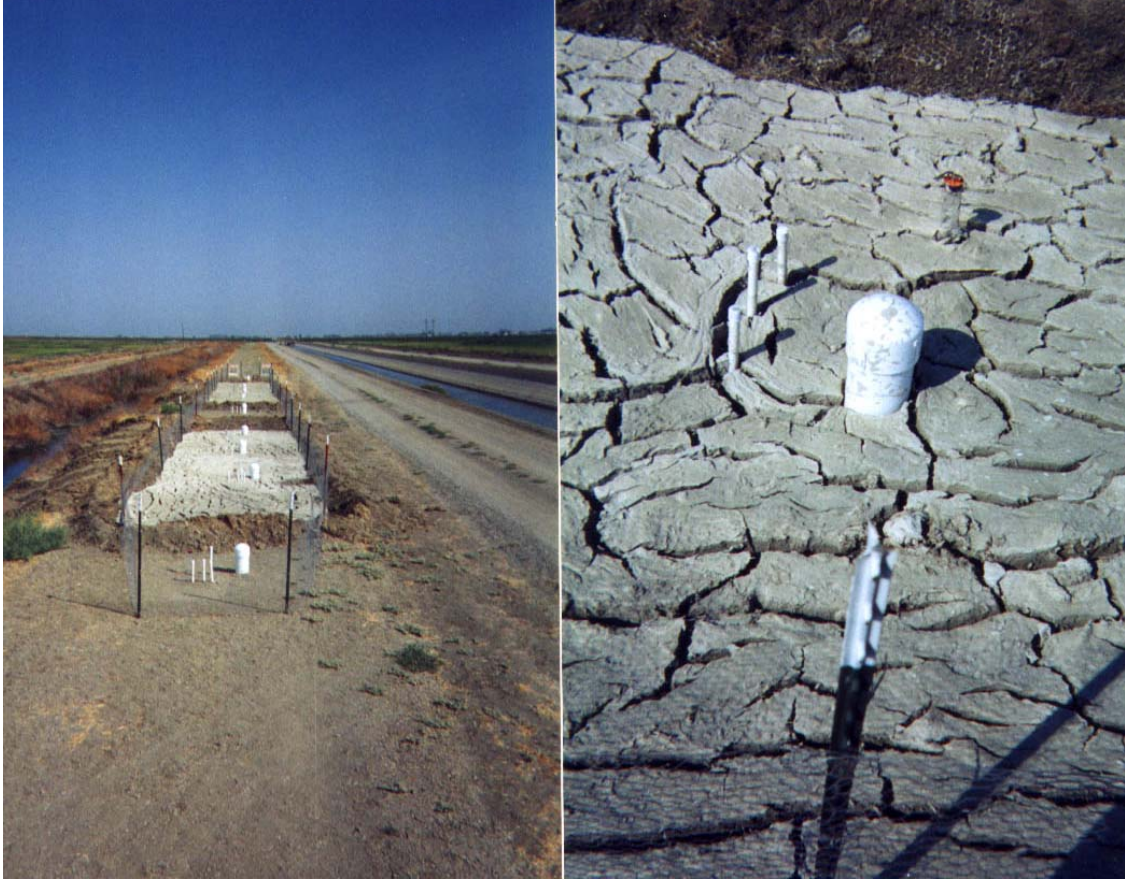
*Figure C.7: Left: Sites EP-2 and EP3 after a few days of drying (9/9/99). Right: Close-up view of drying cracks around one of the monitoring cluster.*

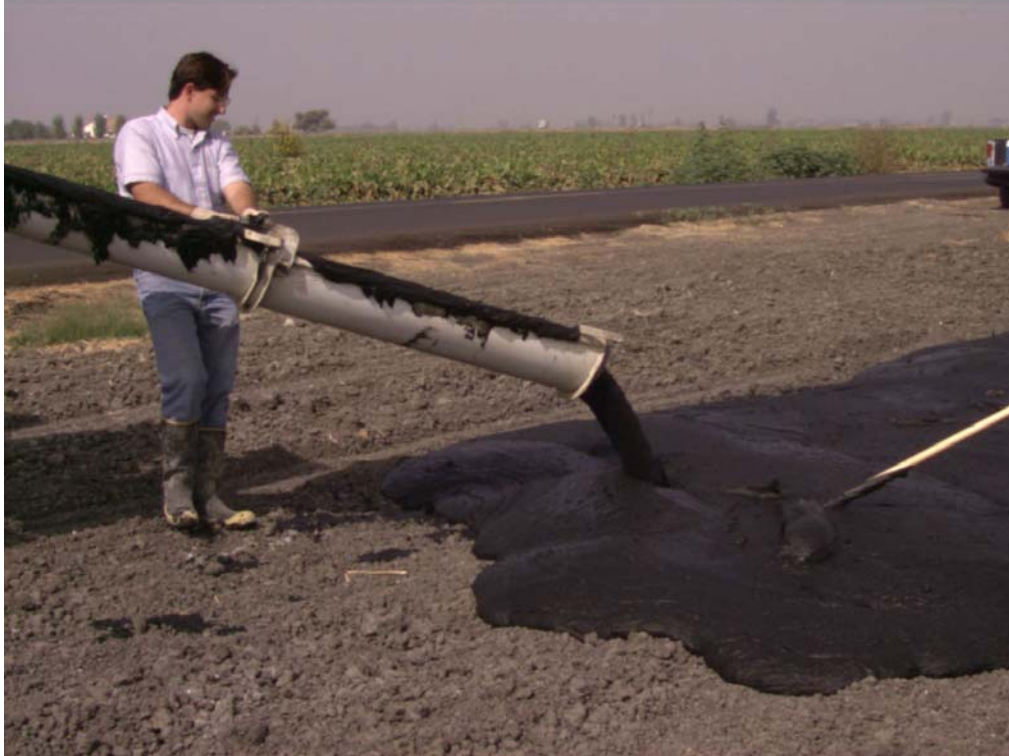
*Figure C.8: Application of SLD sediments to FP-1 using cement-truck chute (10/21/99).*
